Failure of a Cut Slope and Deterioration of Shear Strength due to Weathering

Mochizuki, Akitoshi; Ma, Xianfeng; Sockheang,
Sreng

Mochizuki, Akitoshi ...[et al]. Failure of a Cut Slope and Deterioration of Shear Strength due to Weathering. Proceeding of TC302 Symposium Osaka 2011 : International Symposium on Backwards Problem in Geotechnical Engineering and Monitoring of G ...

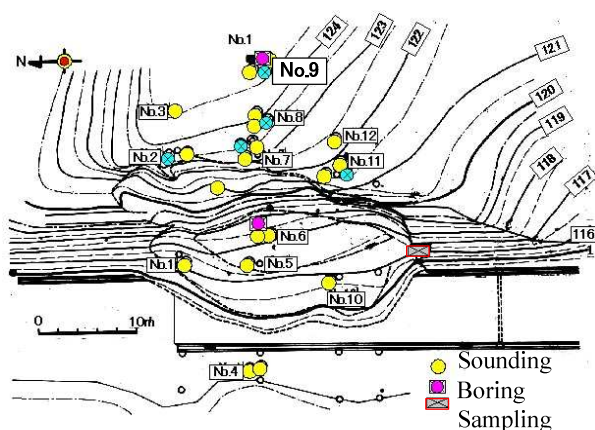
Fig. 3 Topographic map of failure site

Fig.3 shows a plan of the area around the landslide and the location of *in-situ* sounding tests.

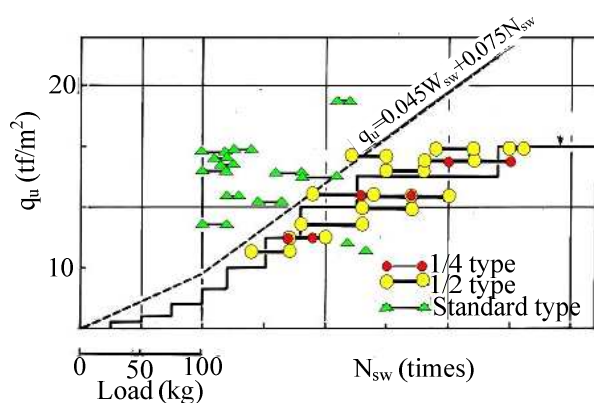
Fig. 5 Relationships of N_{sw} to q_u
: Swedish sounding test

Fig.5 shows a correlation between strength of unconfined compression tests (q_u) and the half-rotation number obtained from the sounding test (N_{sw}) at borehole No.9. The value of N_{sw} is plotted by a pair of symbol marks against q_u -value since N_{sw} was observed at every 10 cm, whereas q_u was measured every 50cm to 100cm.

A step-like relationship between N_{sw} and q_u for the sounding test with 1/2 of the standard weight, as shown in Fig.5, is adopted. The dotted line in the figure was presented by Inada (1954) for the standard tester, however, this equation gives comparatively higher q_u -values than results obtained from an unconfined compression test carried out on the clay.

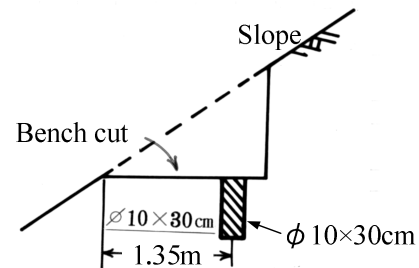
Fig.8 Bench cut and sampling tube

Un-weathered and undisturbed samples for a series of direct shear tests were taken from borehole No.9 and others were taken from the horizontal surface of a bench cut near the failure zone by driving thin walled tubes measuring 100mm in diameter and 3000mm in length (see Fig. 8). Samples from the bench cut shown had a light-brown color suggest

ing that it weathered more than those sampled from the borehole.
